# Manhole Inspection Summary

Manhole # S47AA\_004MH

Insp Date: **6/23/08 8:42 AM**

**Location** Address: **Patterson Park**

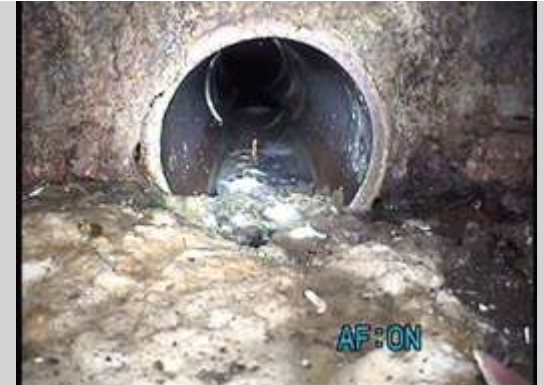
12 O'Clock Outflow

8 in. Circular Gravity Sewer  
Pipe Out @ 12 O'Clock

Pipe Height: **8.4** (in.) Rod and Bar (Angled)  
Pipe Material: **Clay** ☐ Pipe Lined  
Invert Depth: **9.25** (ft.) Flow Characteristics: **None**  
Deposits: ☒ None ☐ Mud ☐ Sludge ☐ Debris ☐ Grease  
Silt Depth: (in.) Deposits Extent:  
Infiltration: **None** Pipe Seal Cond: **Sound**

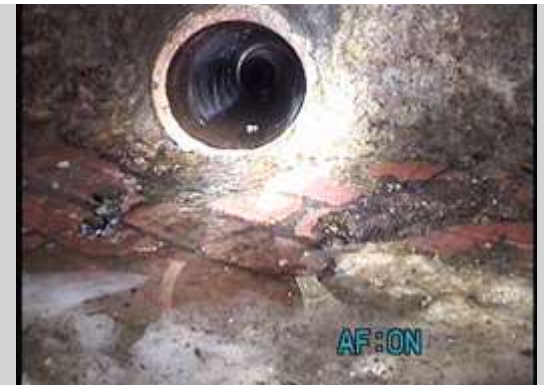
7 O'Clock Inflow

6 in. Circular Gravity Sewer  
Pipe In @ 7 O'Clock

Pipe Height: **6** (in.) Rod and Bar (Angled)  
Pipe Material: **Clay** ☐ Pipe Lined  
Invert Depth: **8.75** (ft.) Flow Characteristics: **None**  
Deposits: ☒ None ☐ Mud ☐ Sludge ☐ Debris ☐ Grease  
Silt Depth: (in.) Deposits Extent:  
Infiltration: **None** Pipe Seal Cond: **Sound**
